THE BIG FLOOD: WILL IT HAPPEN AGAIN?

What causes river bank mass failures?

Quantifying different riverbank erosion processes during an extreme flood event

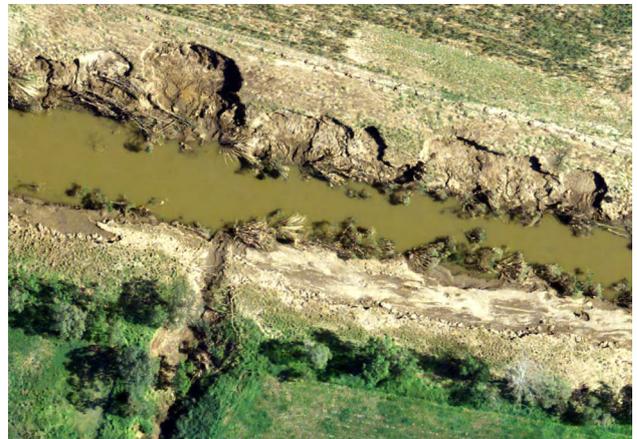
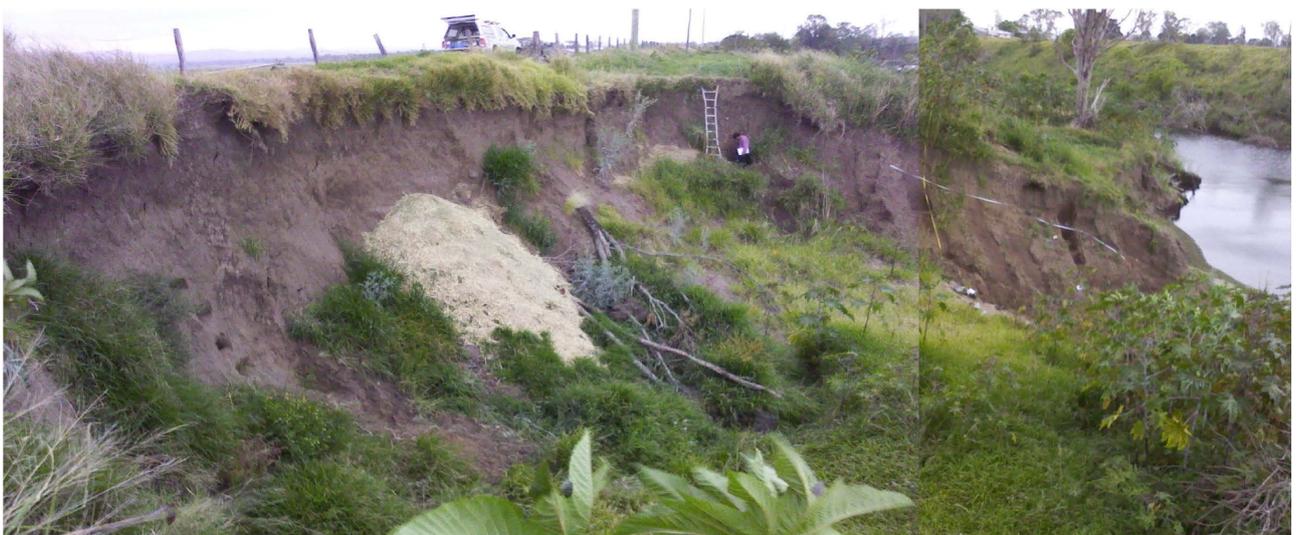
The scalloped river bank erosion in the Lockyer Creek resulted from wet-flow bank mass failures. These form after prolonged floods which have saturated the bank. When floodwaters recede, water drains out of the bank through sand layers lying above clay loam layers, leading to the collapse of the bank into the channel.
